## Windstorm Mitigation Report (OIR-B1-1802)

Sunfish Bay Condominium Association, Inc.

Bldg E, 1111 N Bayshore Blvd, Units 1-12, 15

As of 11-05-2025 | FPAT File# MUD2525702

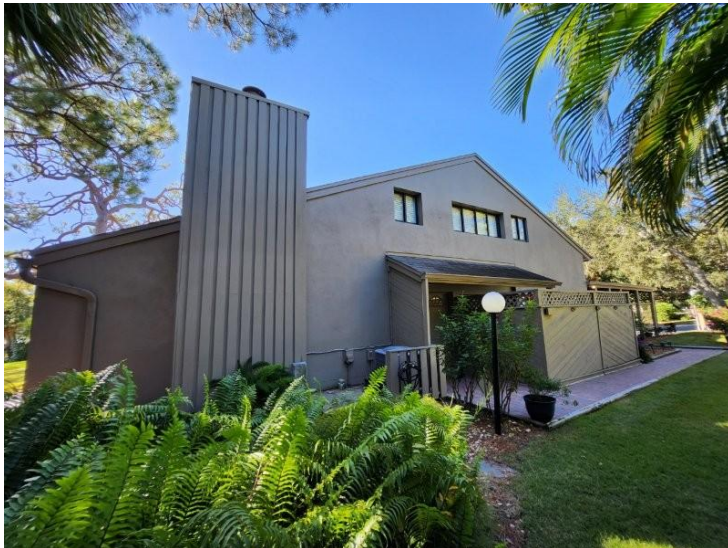
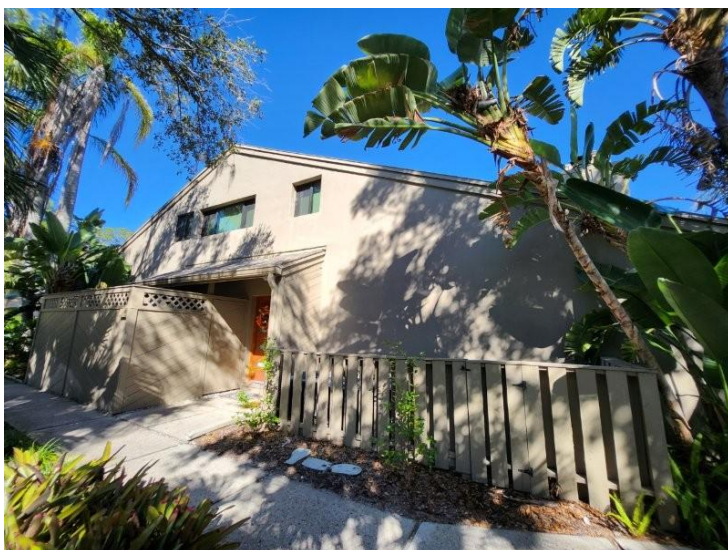
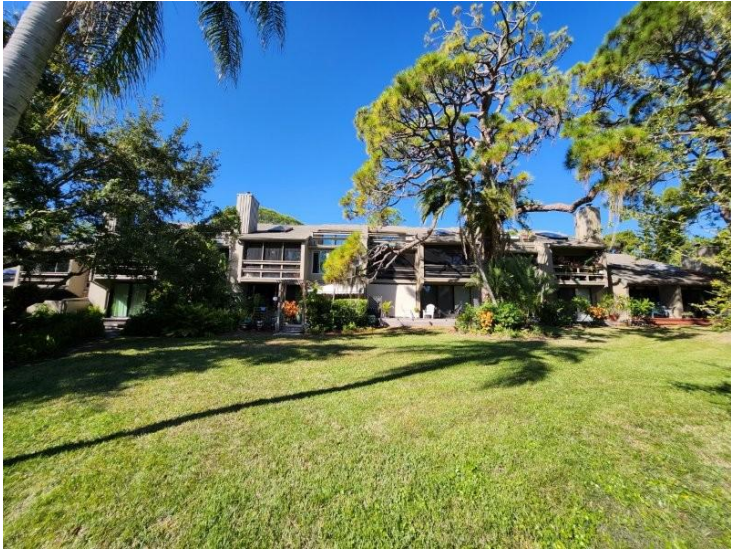
Exterior Elevation

| <b>5. Roof Geometry:</b><br>Comments: | <b>Other Roof</b><br>Inspection verified a gable roof shape. |
| <b>7. Opening Protection:</b><br>Comments: | <b>None or Some Glazed Openings</b><br>No opening protection verified at the time of inspection. |

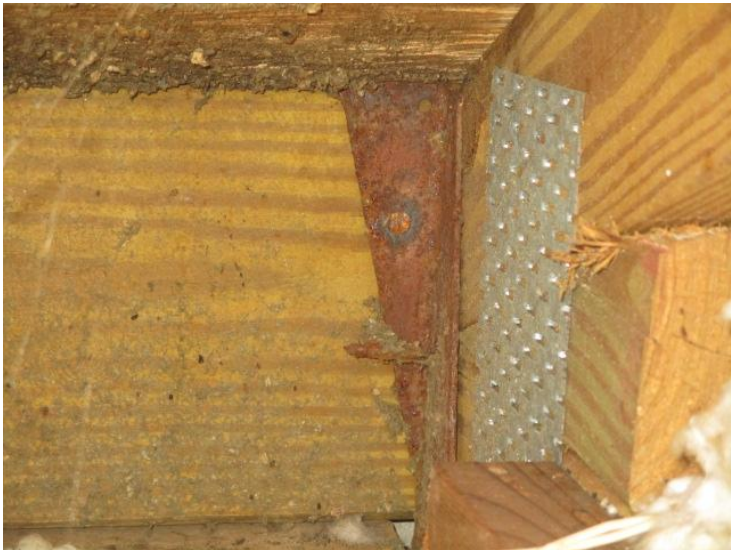
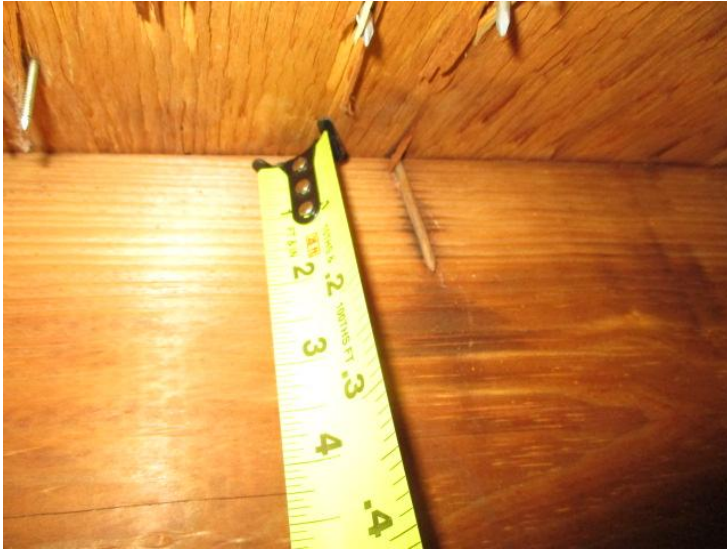
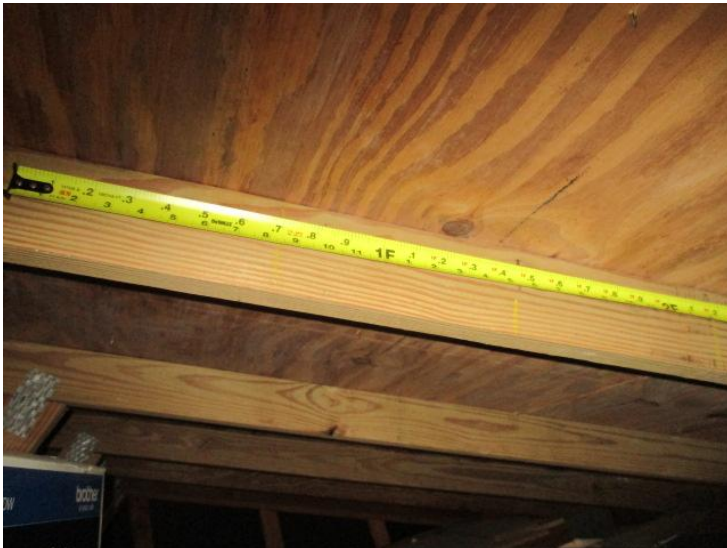
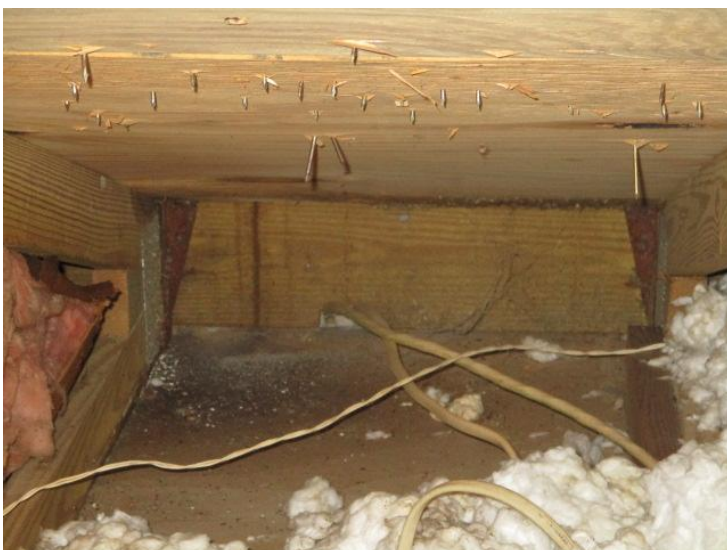
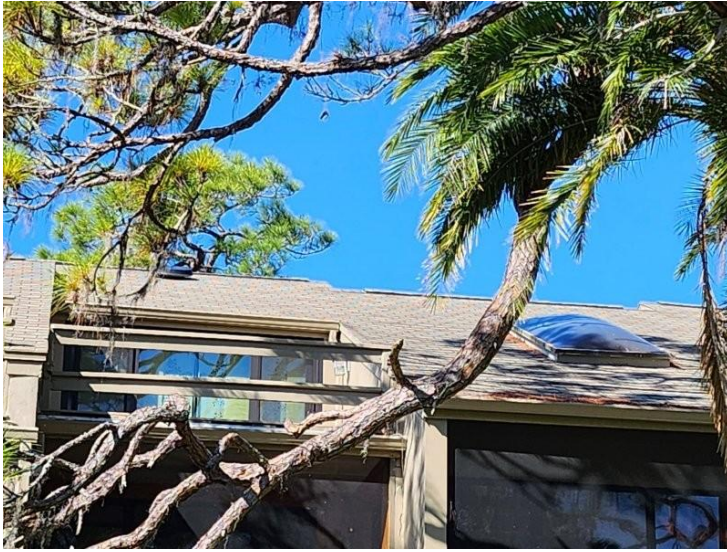
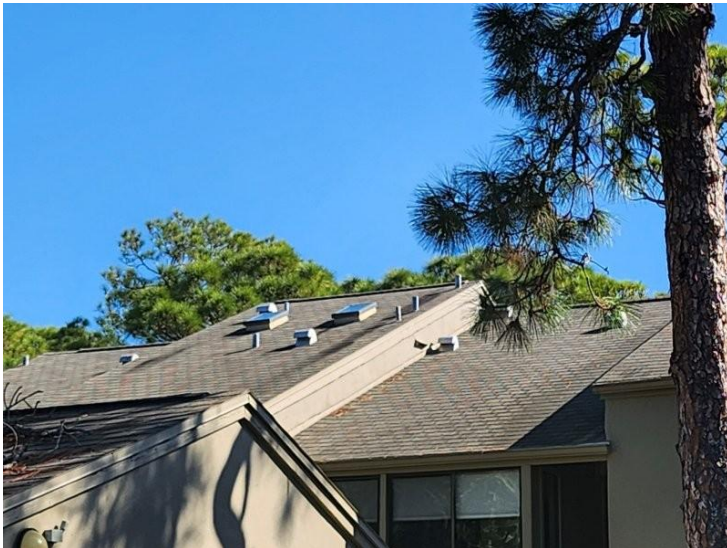
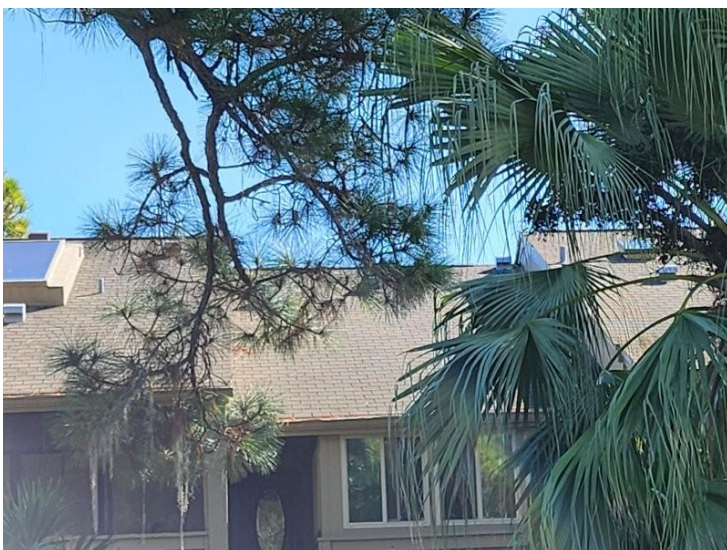
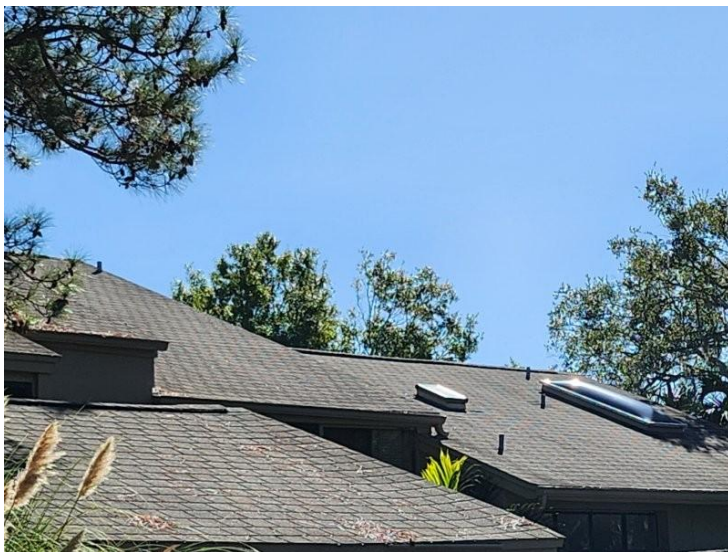
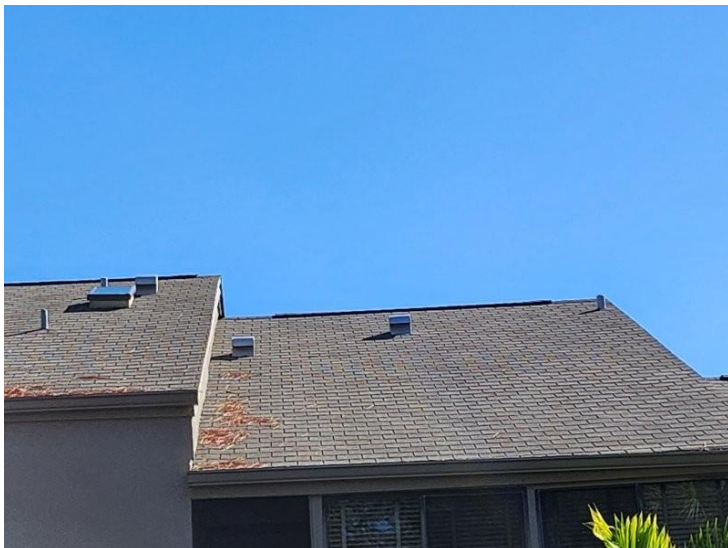
Roof Construction

| <b>3. Roof Deck Attachment:</b><br>Comments: | <b>Level B</b><br>Inspection verified 1/2" plywood roof deck attached with 8d nails at a minimum of 6" on the edge & 12" in the field. |
| <b>4. Roof to Wall Attachment:</b><br>Comments: | <b>Clips</b><br>Inspection verified a metal clip fastened with a minimum of three nails. |
| <b>6. SWR:</b><br>Comments: | <b>No</b><br>No SWR verified. |
