## COMMERCIAL WINDSTORM MITIGATION REPORT (OIR-B1-1802)

Sunfish Bay Condominium Association, Inc.

1111 N Bayshore Blvd, Building E, Units 1-12, 15

As of 2/7/2020

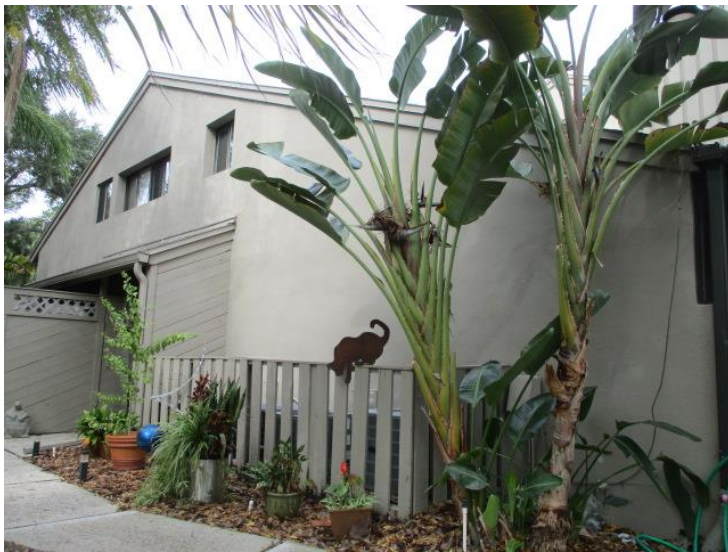
5. **Roof Geometry:**                      **Other Roof**  
Comments:                                      Inspection verified a gable roof shape.
6. **SWR:**                                      **No**  
Comments:                                      No SWR verified.

Exterior Elevation

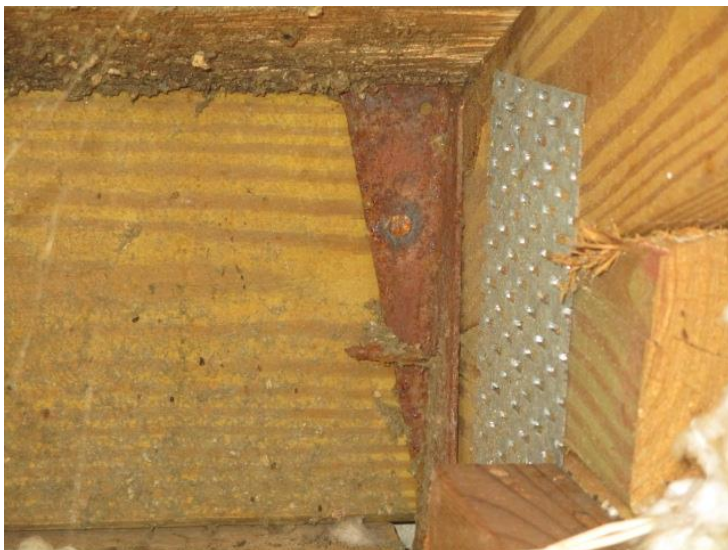
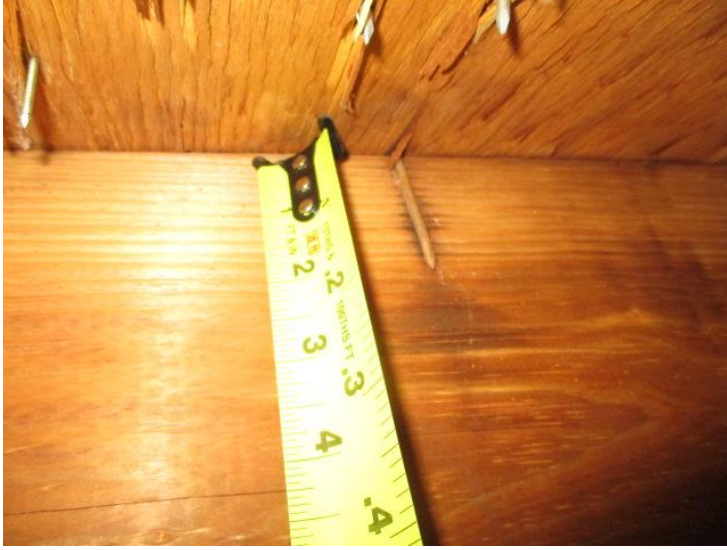
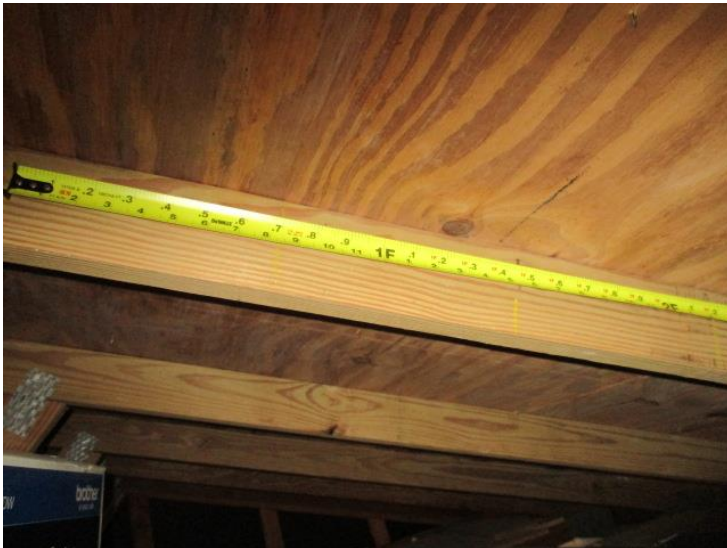
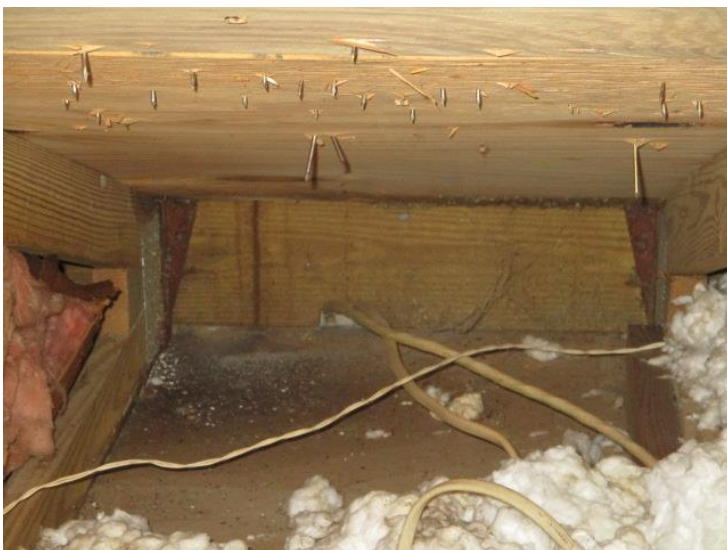
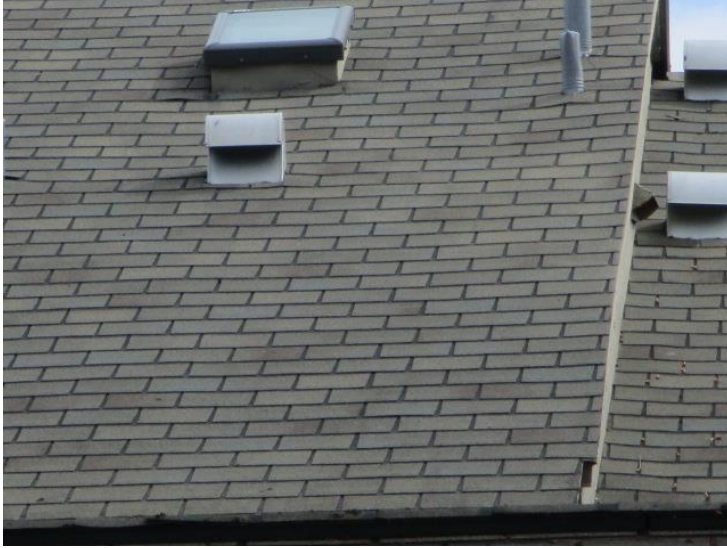
3. **Roof Deck Attachment:**        **Level B**  
Comments:                                      Inspection verified 1/2" plywood roof deck attached with 8d nails at a minimum of 6" on the edge & 12" in the field.

4. **Roof to Wall Attachment:**        **Clips**  
Comments:                                      Inspection verified a metal clip fastened with a minimum of three nails.

Roof Construction
