# Windstorm Mitigation Report

Sunfish Bay Condominium

## **Windstorm Mitigation Report (OIR-B1-1802)**

1111 N Bayshore Blvd, Building F, Units 1-12, 15

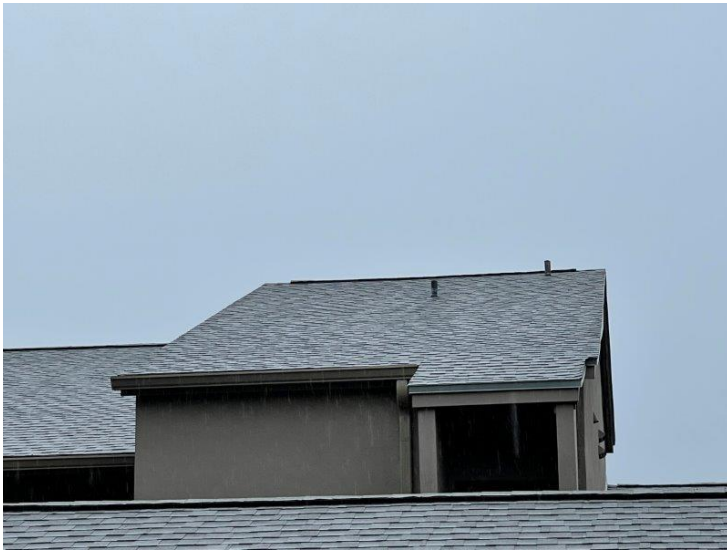
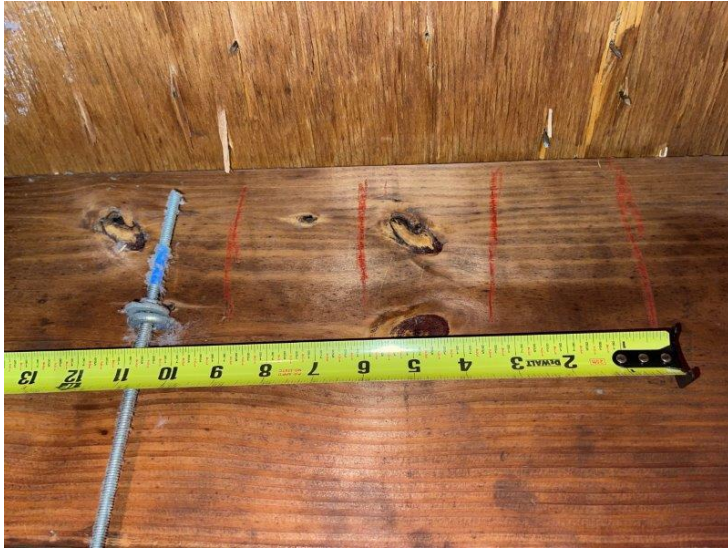
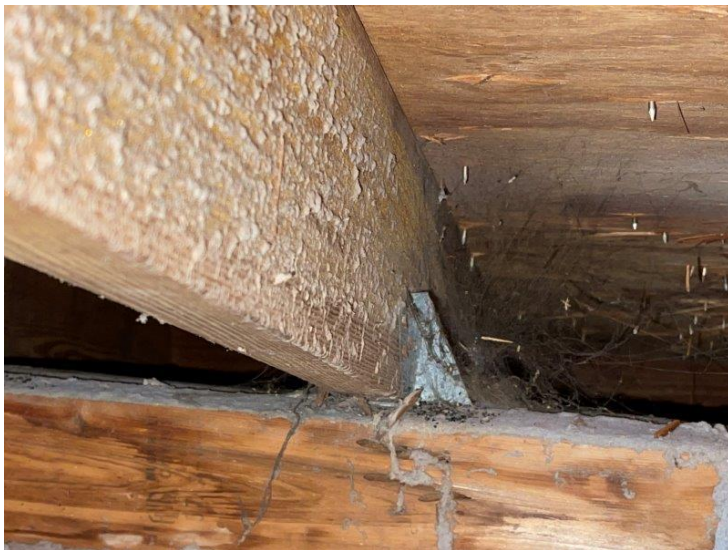
Roof Construction

- 3. Roof Deck Attachment:** **Level C**  
Comments: Inspection verified 1/2" plywood roof deck attached with 8d nails at a minimum 6" on the edge & 6" in the field.

- 4. Roof to Wall Attachment:** **Clips**  
Comments: Inspection verified hurricane clips fastened with a minimum of three nails.
- 5. Roof Geometry:** **Other Roof**  
Comments: Inspection verified a gable roof shape.
